****Field Retrofit Required****

Request for immediate attention!

Precision Medical Regulators

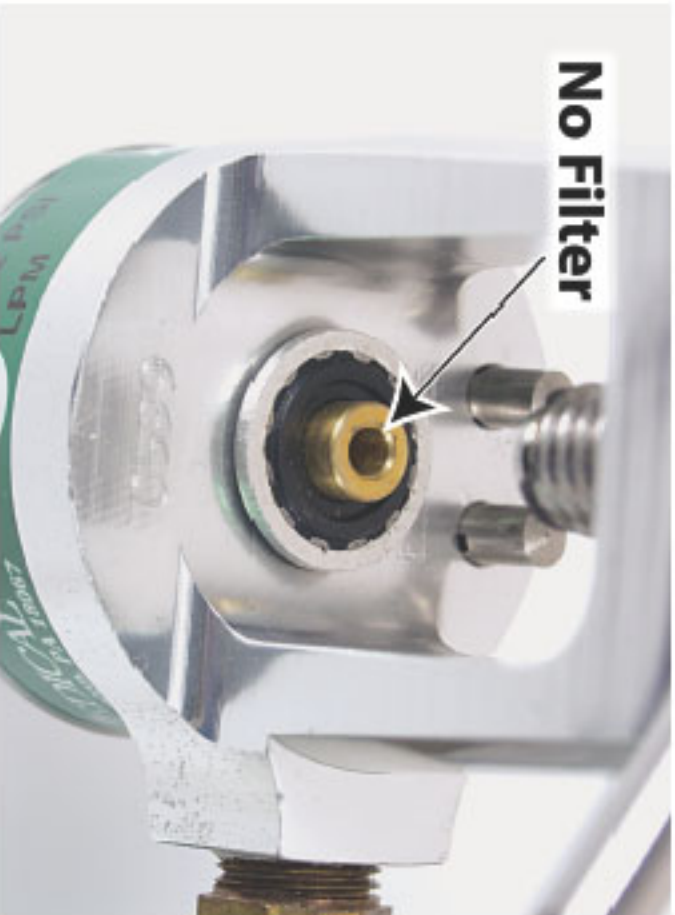
Regulators that do not have the bronze filter in place have the potential of a regulator fire. With the filter in place the risk of fire is greatly reduced, if not eliminated entirely.

No Filter

Customers who have purchased Oxygen regulators before *Sept. of 2000*, should check to ensure that a filter has been placed into the high pressure inlet orifice. (see photo insert for clarification)

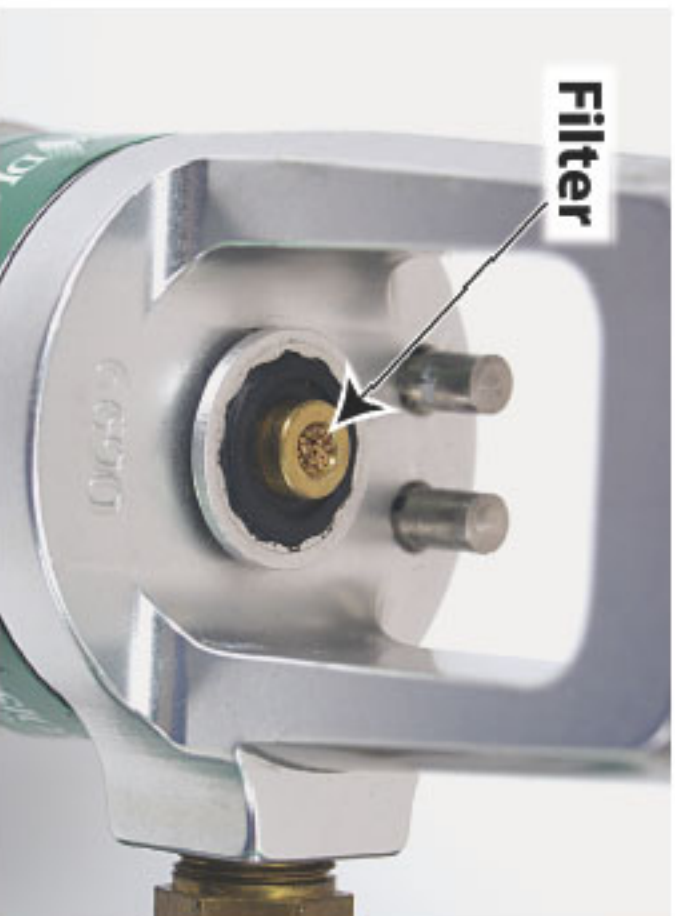
Precision Medical, Inc. Regulators with the filter in place have passed the ignition testing requirement. ASTM G175 “Standard Test Method for Evaluating the Ignition Sensitivity and Fault Tolerance of Oxygen Regulators Used for Medical and Emergency Applications”

Filter
