****Field Retrofit Required****

Request for immediate attention!

Precision Medical Regulators

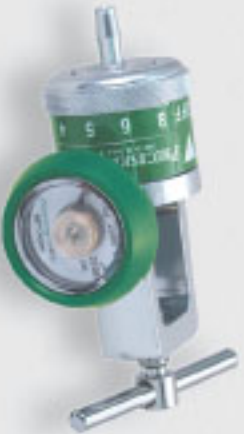
Easy DialReg

Customers who have purchased Oxygen regulators before *Sept. of 2000*, should check to ensure that a filter has been placed into the high pressure inlet orifice. (see photo insert for clarification)

Regulators that do not have the bronze filter in place have the potential of a regulator fire. With the filter in place the risk of fire is greatly reduced, if not eliminated entirely.
